VERMILION HARBOR, OHIO CONDITION SURVEY REPORT

STUDY OF THE IMPACT OF THE OFFSHORE BREAKWATER ON

U.S. ARMY CORPS OF ENGINEERS
BUFFALO DISTRICT
1776 NIAGARA STREET
BUFFALO, NEW YORK 14207

83 03 11 030, September 1982

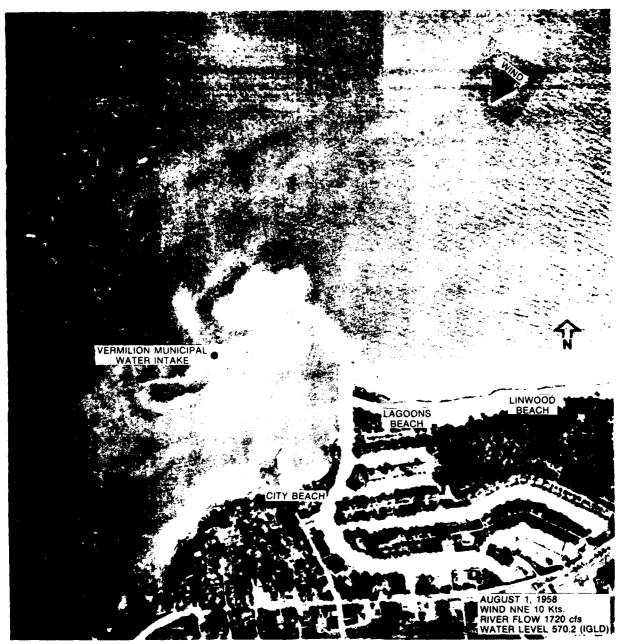
Photo 4 • SHOWS SOME INFLUENCE ON WATER INTAKE.

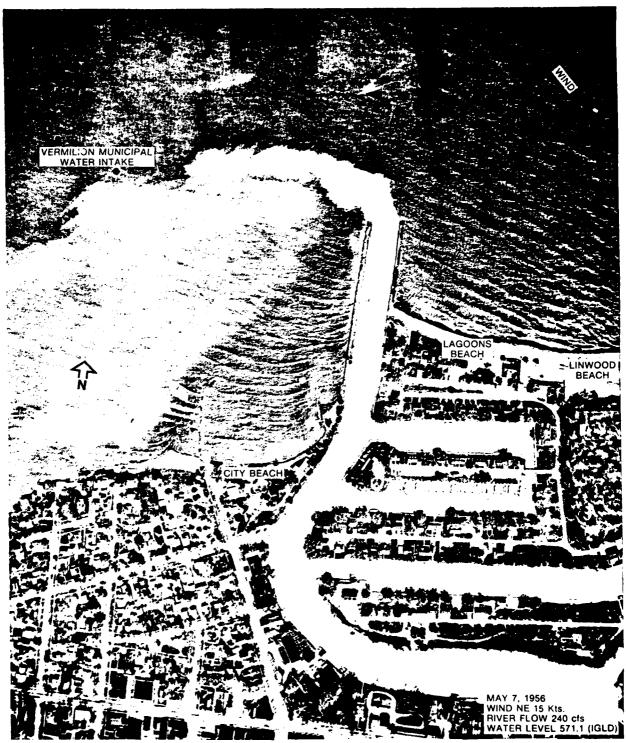
Photo 5 - RIVER PLUME DEFLECTED SHARPLY BY STRONG NORTHEAST WIND

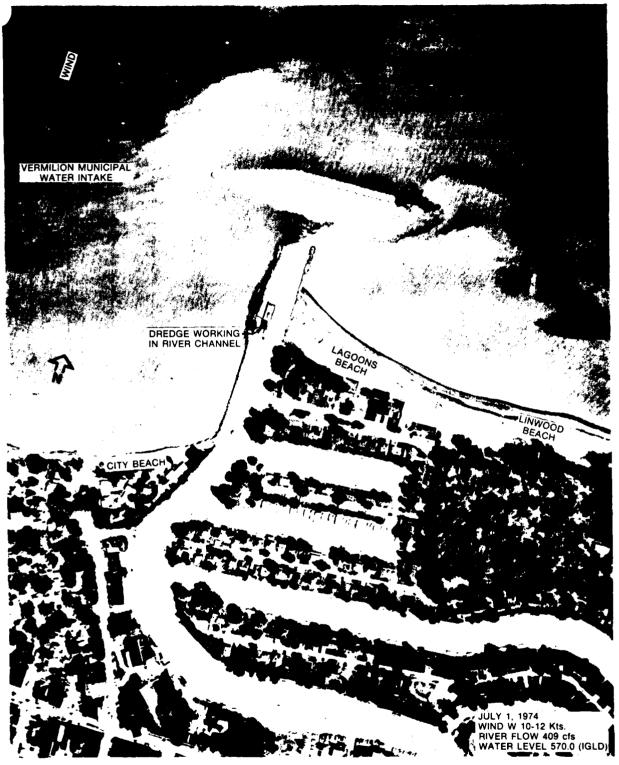
West Through Southwest. Winds from these directions are the prevailing winds. Photos 6 through 8 show the effect on the plume by these winds in pre and postbreakwater periods. Photo 7 shows the Vermilion River water moving essentially offshore (north) during moderate southwesterly winds. A comparison of Photos 7 and 8, taken during similar wind conditions, indicates that the breakwater appears to force river water along the Lagoons and Linwood swimming areas.

Photo 6 • BREAKWATER DEFLECTS CURRENTS TOWARD THE EAST - SOME INFLUENCE ON LAGOONS AND LINWOOD BEACH.

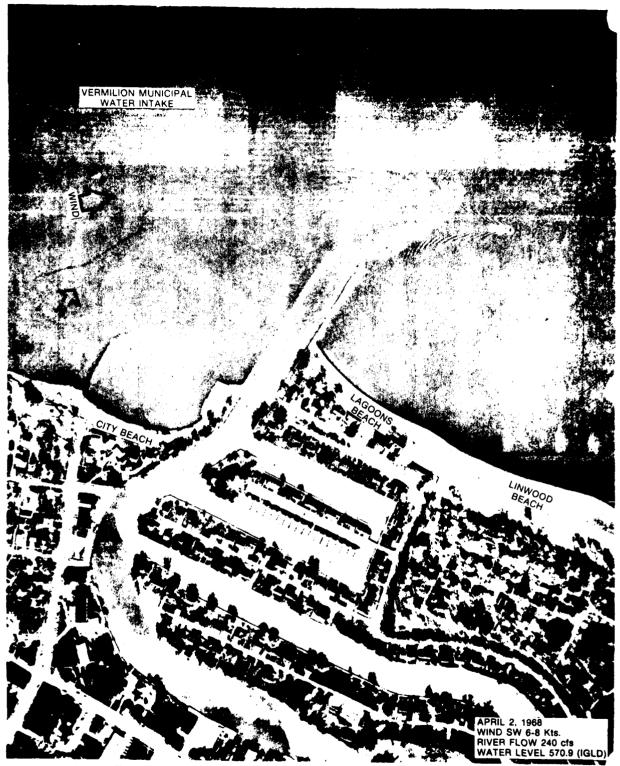
Photo 7 . SHOWS RIVER PLUME MOVING NORTH UNDER SOUTHWEST WIND.

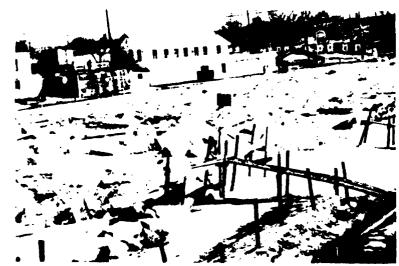
Photo I I • TYPICAL ICE JAM ON VERMILION HARBOR (March, 1963)

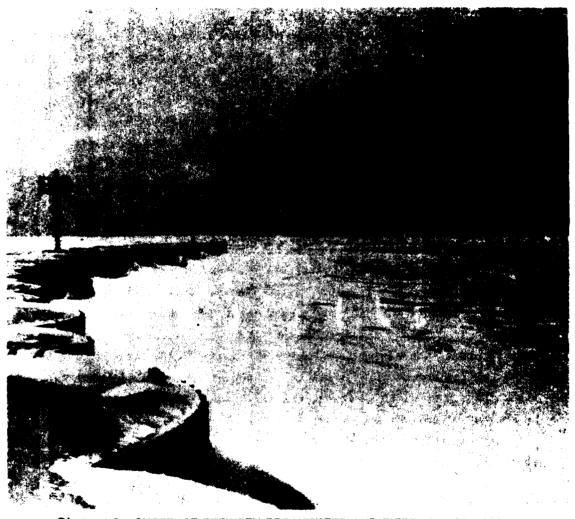
Therefore, in the area around and between the breakwater and the pier ends, the structure has had significant effects on the distribution of ice. The breakwater now presents a physical obstruction to lake ice moving toward the south shore and to a lesser extent ice moving parallel to the shore. Prior to the breakwater, ice was free to move unhindered in the area offshore of the piers (Photograph 10). The distribution of ice packs and windrows formed by the moving ice depended upon the wind and current conditions. Northerly winds tended to pile up windrows at the pier ends and parallel to the shore, while southerly winds transported ice away from the harbor mouth. East or west winds pushed ice against the piers or the fast ice adjacent to the piers. With the breakwater in place, northerly winds pile up windrows at the breakwater (Photograph 9) and east and west winds drive packs against the fast ice in the lake approach channels inside the breakwater. Figure 15 shows the generalized patterns of ice before and after the breakwater construction.

Photo 12 • SHEET ICE BETWEEN BREAKWATER AND PIERS (Jan. 30, 1978)

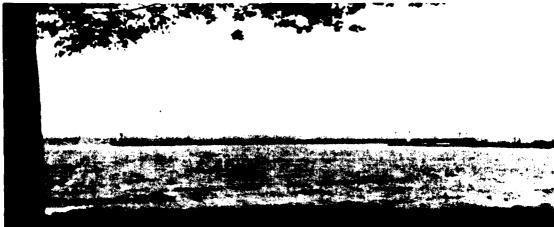
13 • LOOKING EAST FROM THE BLUFF AT NORTH END OF WASHINGTON STREET. BREAKWATER IS A BACKGROUND ELEMENT OF VISUAL INTEREST OR LOW SCENIC QUALITY.

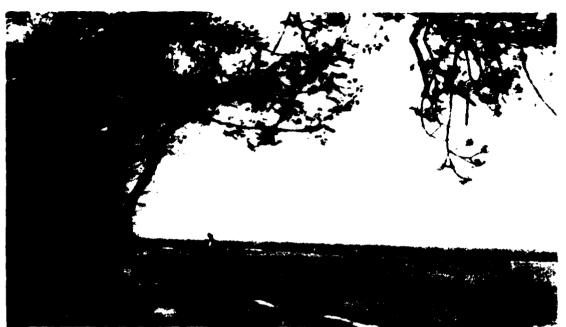
16 • VIEW FROM THE BLUFF NEAR STEPS AT LINWOOD BEACH. THE BREAKWATER IS A BACKGROUND ELEMENT OF VISUAL INTEREST.

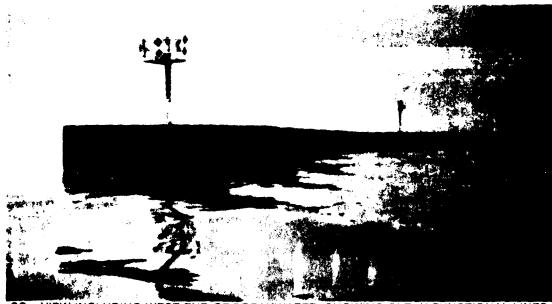
20 • VIEW INCLUDING WEST END OF BREAKWATER. SHOWING CLEAN FUNCTIONAL LINES OF CONSTRUCTION. PICTURESQUE COMPOSITION FROM WATER SIDE IS POSSIBLE WHEN AIDED BY REFLECTION FROM GLASSY WATER.

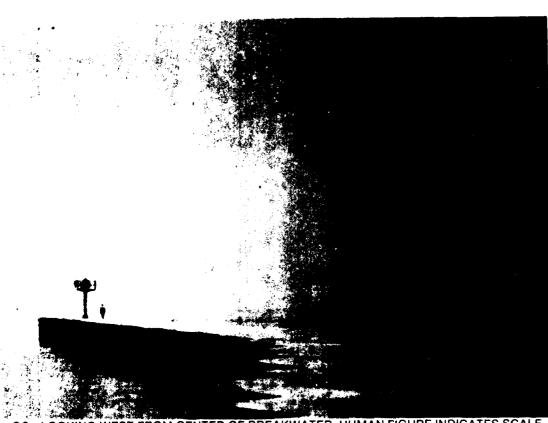
26 • LOOKING WEST FROM CENTER OF BREAKWATER, HUMAN FIGURE INDICATES SCALE OF STRUCTURE. CONCRETE SURFACE AND FUNCTIONAL DESIGN FOR ABOVE WATER PORTION CONTRAST WITH NATURAL MATERIALS OF EXISTING PIERS.

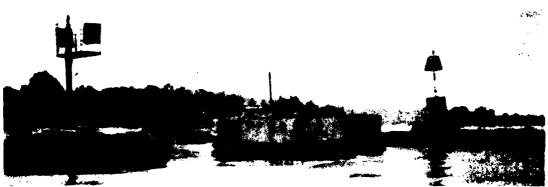
Structures in the harbor and adjacent shore combine with the shallow draft to form a distinctly recreational small craft harbor atmosphere in contrast to the industrial port facilities at Lorain and Cleveland. The large mass of the new breakwater is shown in Photographs 19, 20, 23, 26, 27 and 30. The new structural mass of the breakwater contrasts with the older piers, as shown in Photographs 27, 28, and 29.

27 • LOOKING NORTH FROM EAST PIER. FISHING TUG INDICATES LARGE SCALE OF STEEL BREAKWATER IN BACKGROUND.

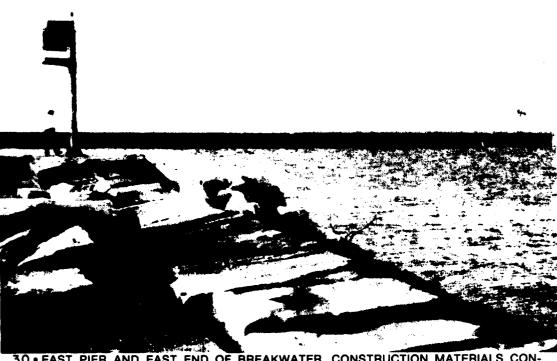
30 • EAST PIER AND EAST END OF BREAKWATER. CONSTRUCTION MATERIALS CONTRAST QUARRIED STONE WITH STEEL SHEET PILING. SCALE OF MATERIAL MODULES IS EVIDENT WHEN RELATED TO HUMAN FIGURE IN PHOTO.
